**City of Bellevue  
Development Services Department  
Land Use Staff Report**

**Proposal Name:** **Somerset Slope Revegetation & Deck Rebuild**

**Proposal Address:** **13607 SE 55<sup>th</sup> Place**

**File Number:** **21-10667 LO**

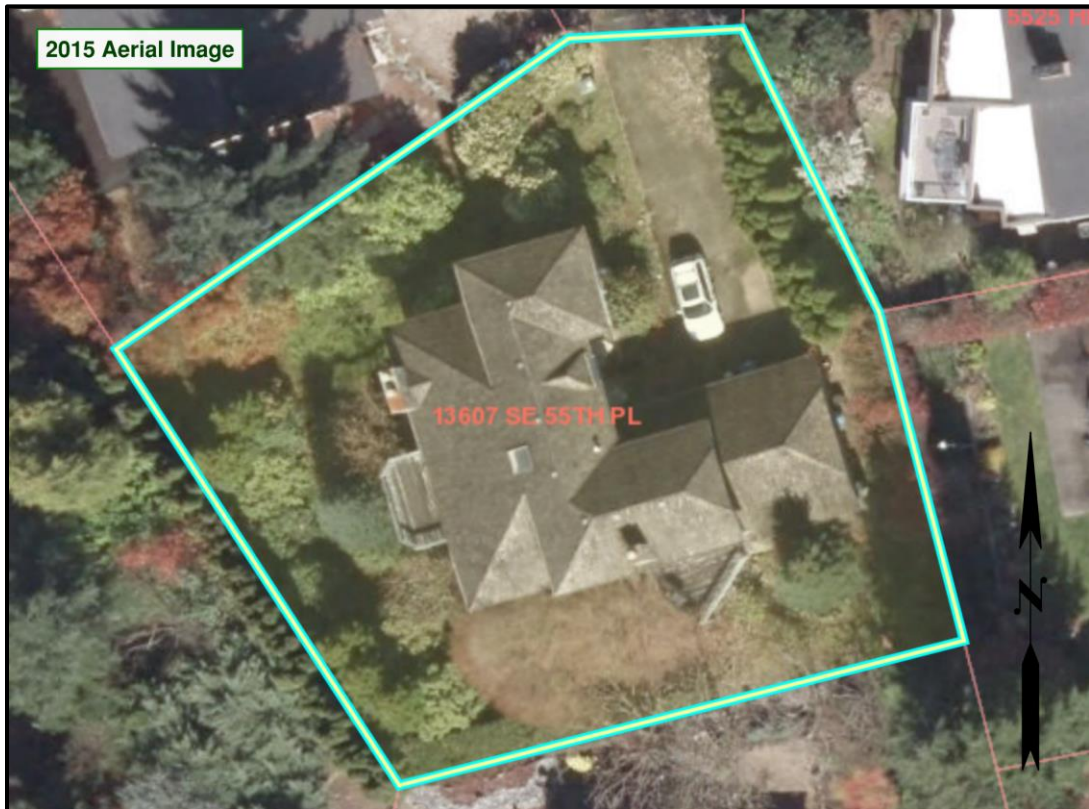
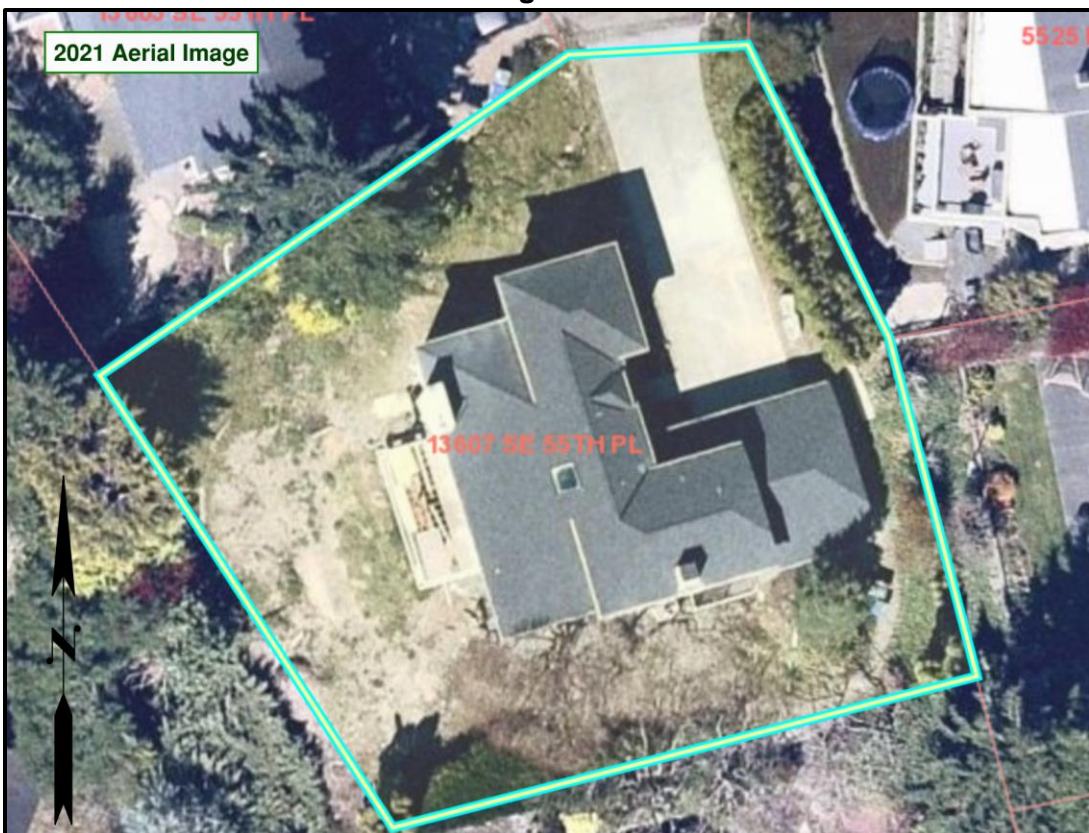
The existing vegetation consists of trees, shrubs, and ground cover. Nearly all trees, shrubs and ground cover vegetation were removed from the steep slope buffer. No grading has occurred on the site. See Figure 3 below for previous site conditions and current site conditions. A portion of the existing single-family residence is located in the buffer; however, per LUC 20.25H.035.B, the buffer is modified to exclude the footprint of an existing primary structure that was legally established on the site prior to August 1, 2006. The existing residence was constructed in 1979 according to the King County Assessor records. See Figure 3 below for the site conditions prior to reconstruction of the deck and vegetation removal and see Figure 4 for current site conditions.

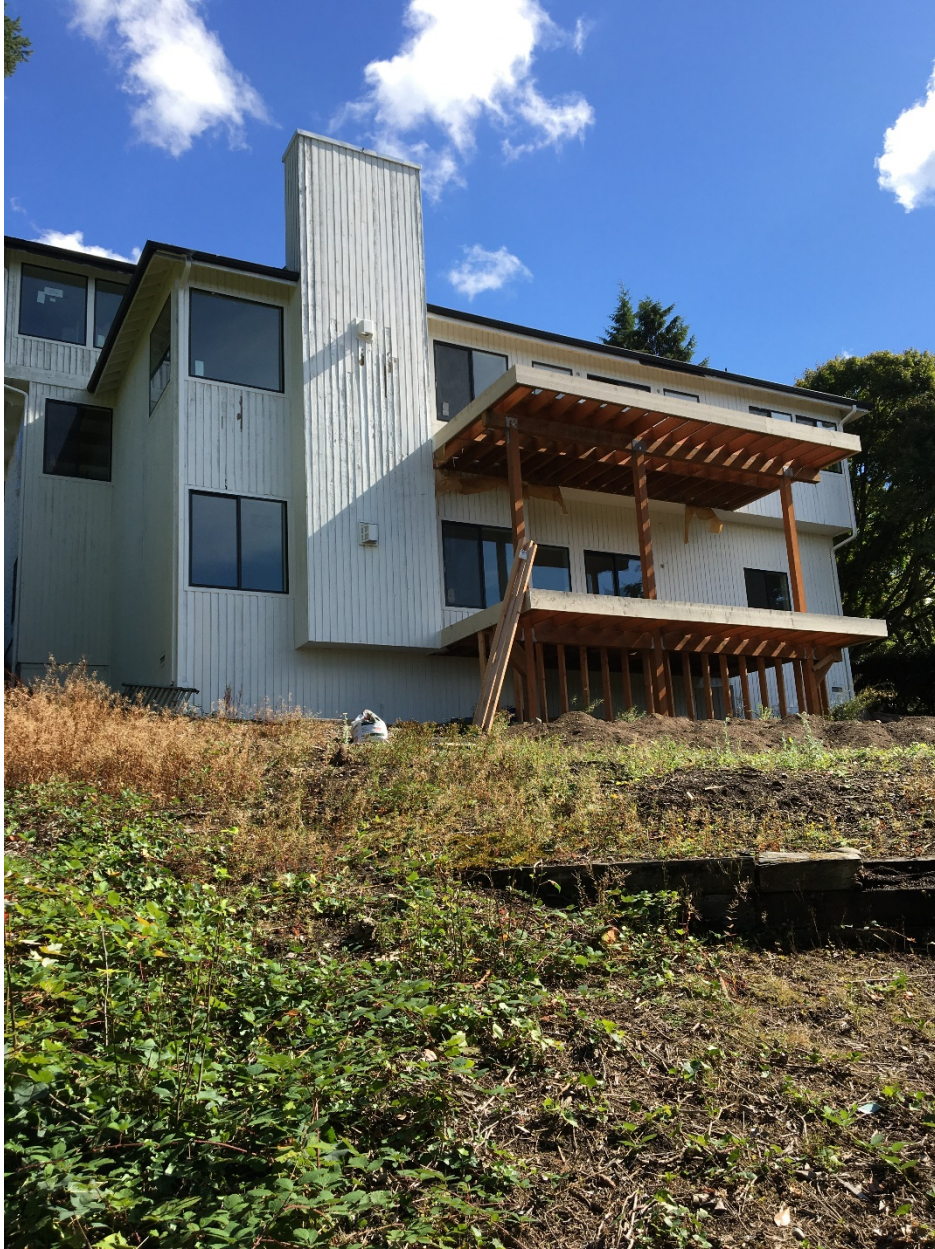
Photo 1 – New deck construction in progress looking east

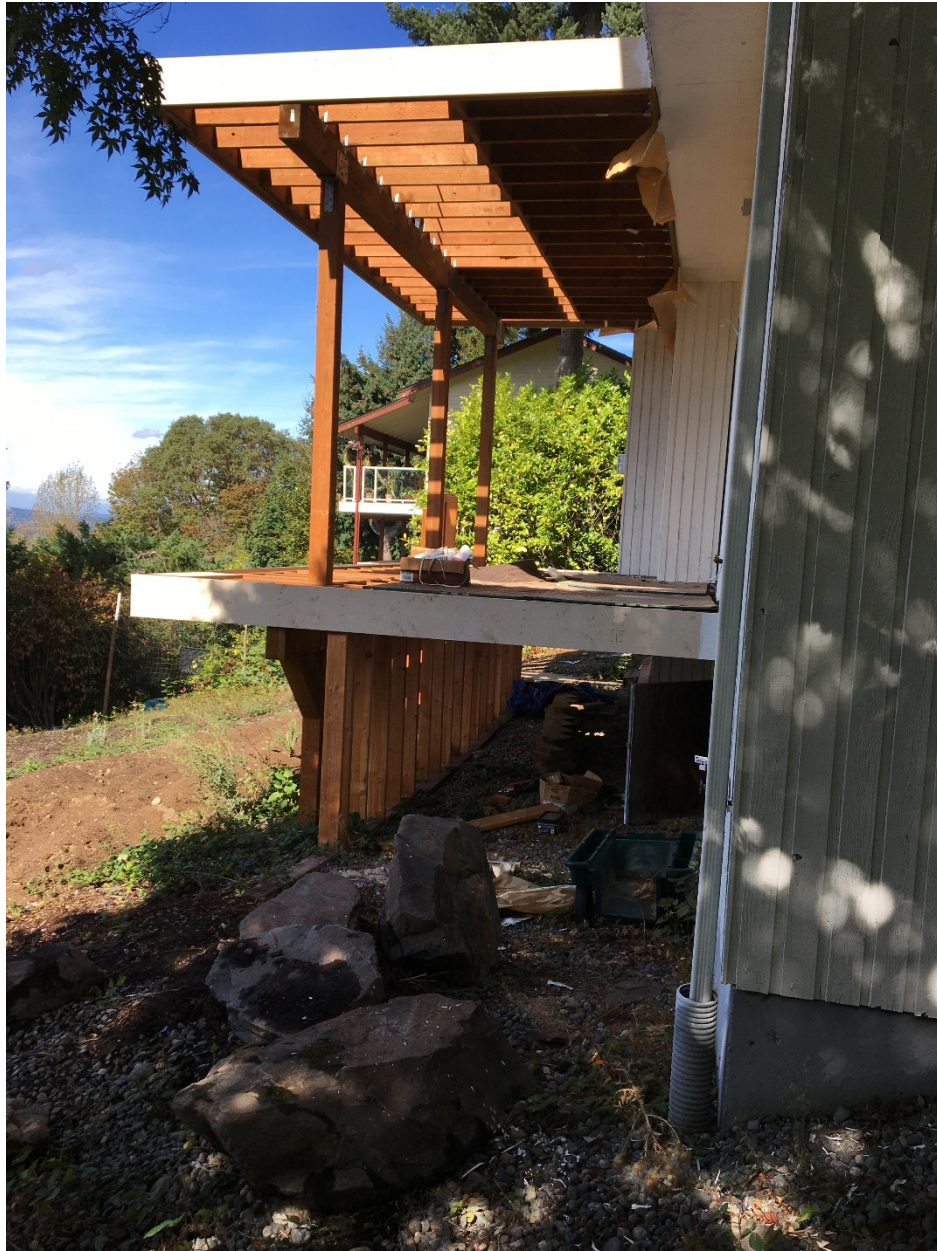
Photo 2 – New deck construction in progress showing temporary wood framing

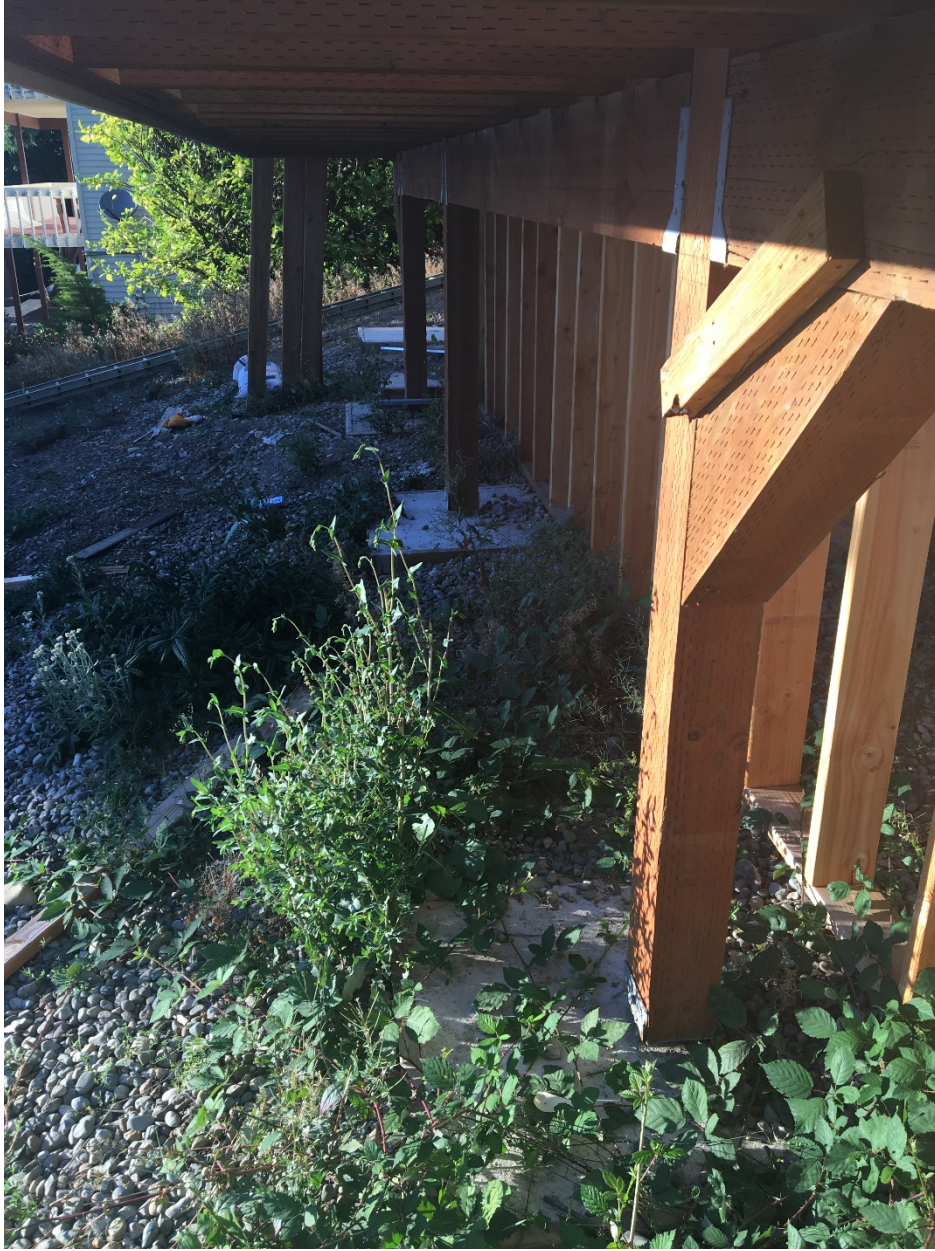
Photo 3- New deck construction in progress showing support posts and pad footings

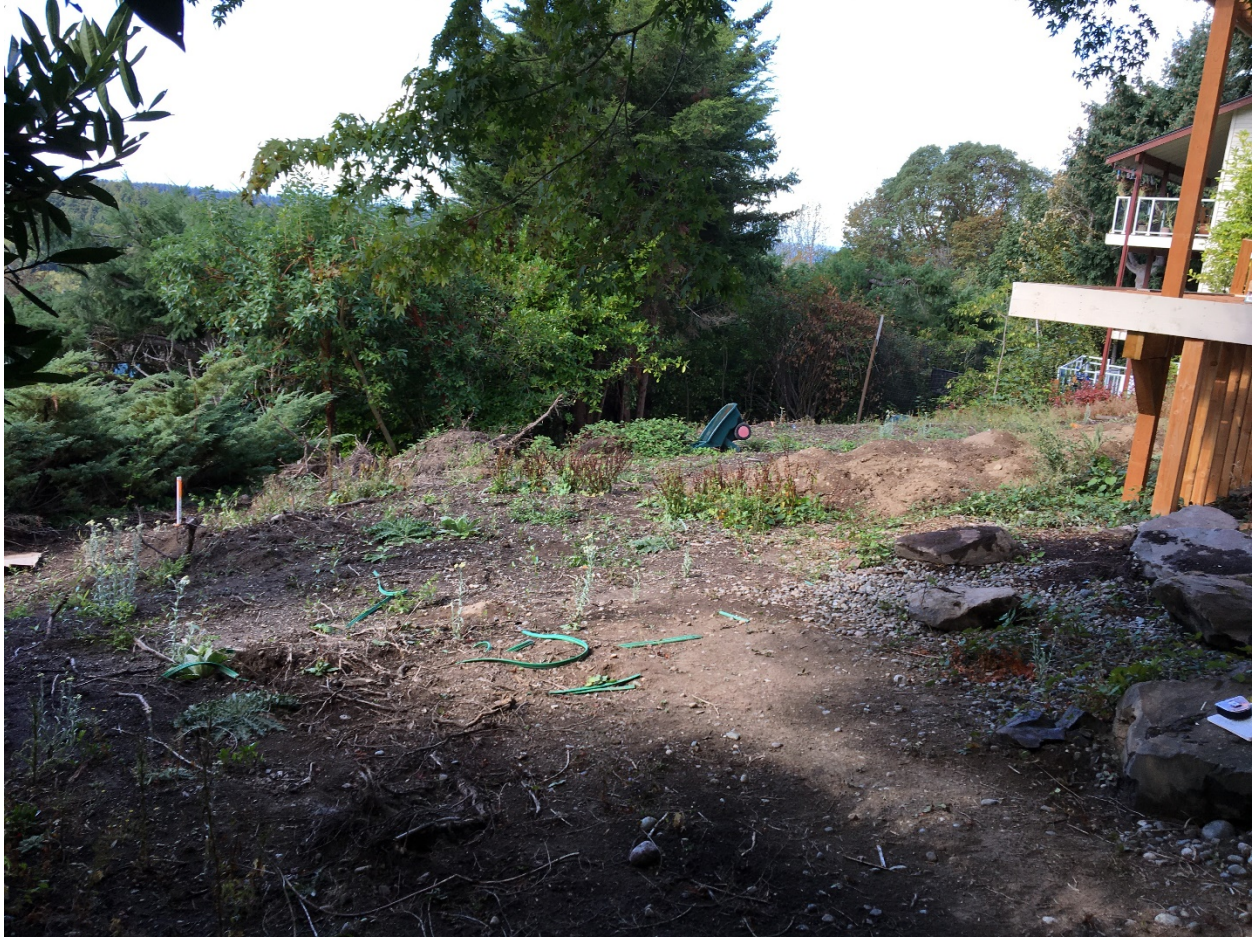
The area between the house and steep slope has been cleared and is mostly bare soil except for sporadic weed growth. This area slopes gradually toward the west at an inclination of 3H:1V (Horizontal:Vertical) to 5H:1V. Near the top of the slope we observed a short wall composed of old railroad ties that is up to 2 feet tall.

Photo 4 – Backyard looking west toward steep slope

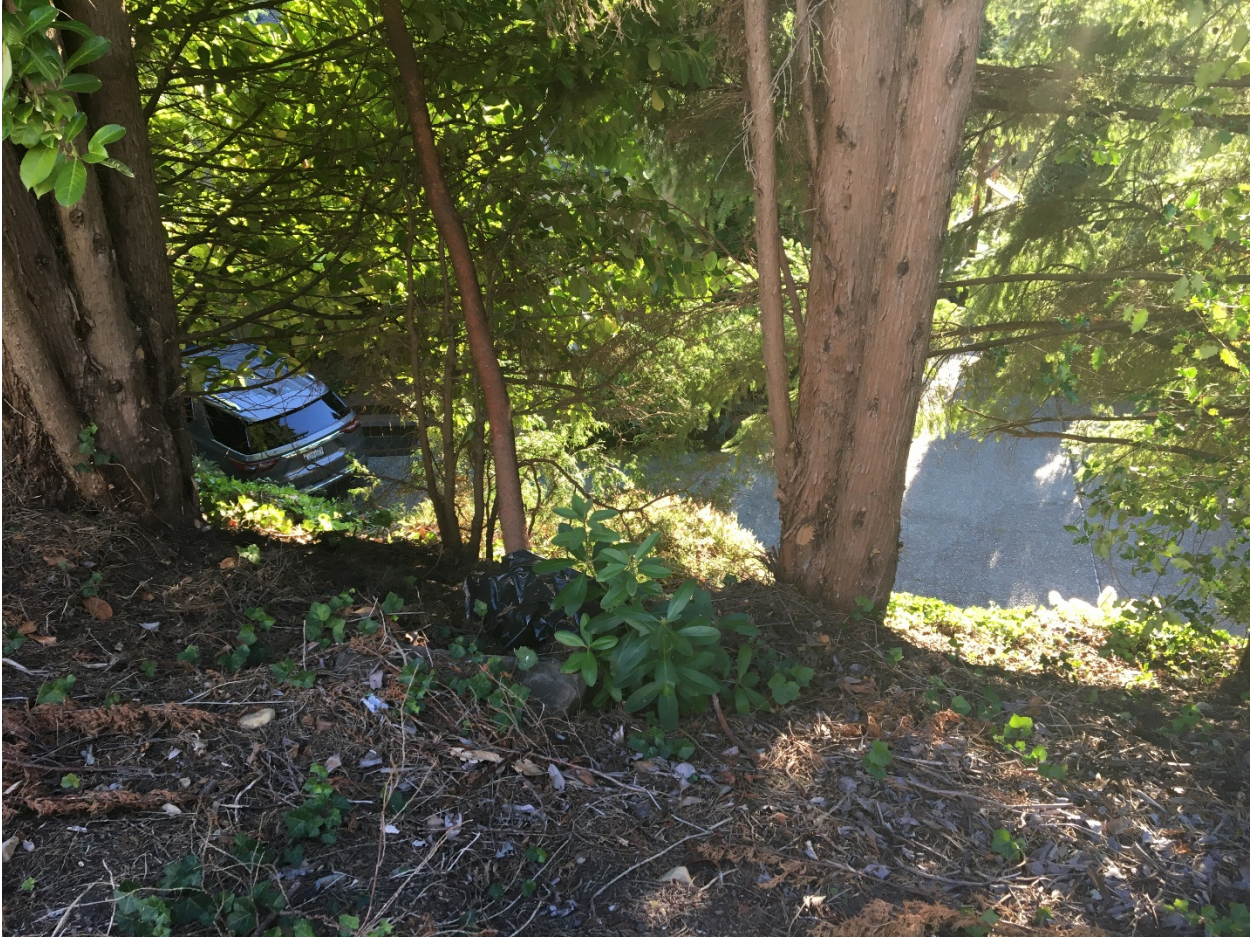
The steep slope is about 15 feet tall and inclined at 75 to 100 percent. We observed the slope was moderately vegetated with cedar trees, madrone, ivy, juniper, and laurel bushes. From your property, we observed no evidence of instability on the steep slope such as bowed or leaning trees, tension cracks, or slumps. We also did not observe any groundwater seepage or evidence of erosion on the slope.

Photo 5 – Steep slope looking west and down toward adjacent neighboring property
